MSP430G2755 Device Erratasheet

1 Revision History

3 Detailed Bug Description

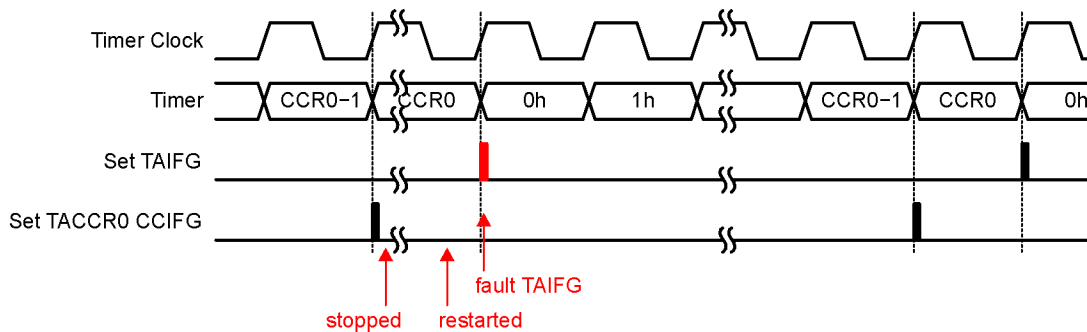
TA21

Function TAIFG Flag is erroneously set after Timer A restarts in Up Mode

Description In Up Mode, the TAIFG flag should only be set when the timer counts from TACCR0 to zero. However, if the Timer A is stopped at TAR = TACCR0, then cleared (TAR=0) by setting the TACLr bit, and finally restarted in Up Mode, the next rising edge of the TACLK will erroneously set the TAIFG flag.

Workaround None.
